M50 Manifold Install Trouble

Shooting Guide

TROUBLE SHOOTING GUIDE

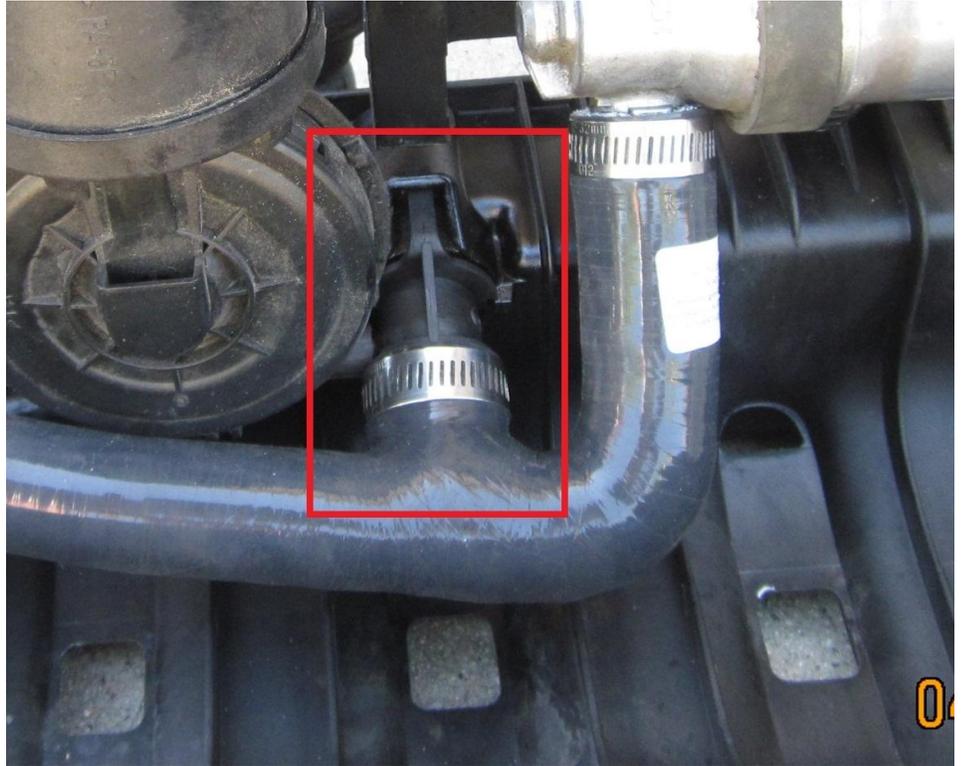
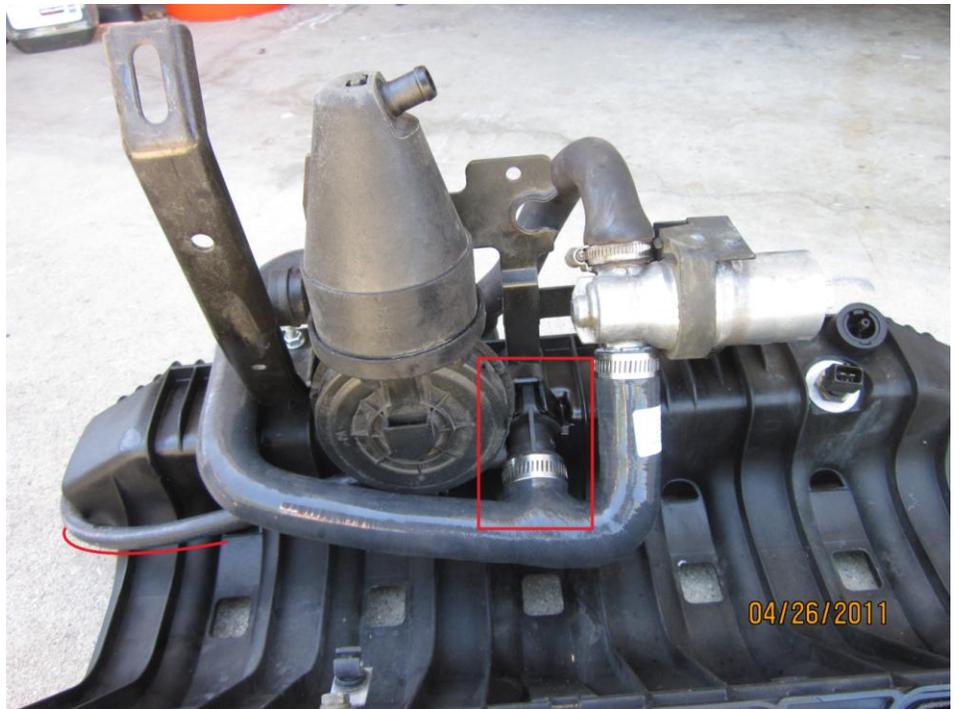
#1 – BMW ICV Connector - The top of the list for causing vacuum leaks is the large BMW connector in the back of the manifold. This connector is the central piece of the hose connector system that joins the ICV, the Crank Vent, and purge valve into the manifold vacuum system. If there is a leak here your car may idle erratically, inconsistently idle well then poorly then well again, your engine may not even idle at all. **THIS IS THE #1 CAUSE OF VACCUM LEAKS.**

Make sure the connector is installed squarely and that the retainer clip/barb is not broken off. Sometimes the connector can be installed crooked/cooked without the clip breaking off but this is more rare. If you suspect this is where your leak may be you can see/access this connector clearly by removing the throttle body and looking/feeling directly into the manifold.

Author Rant - This part should have never even been a separate part. It should have been a molded nipple on the manifold like the brake booster nipple is. There is no reason why you can't use some very high grade (high temp) epoxy and permanently glue it in place. The FI guys almost have to do this in order to keep from blowing it out.

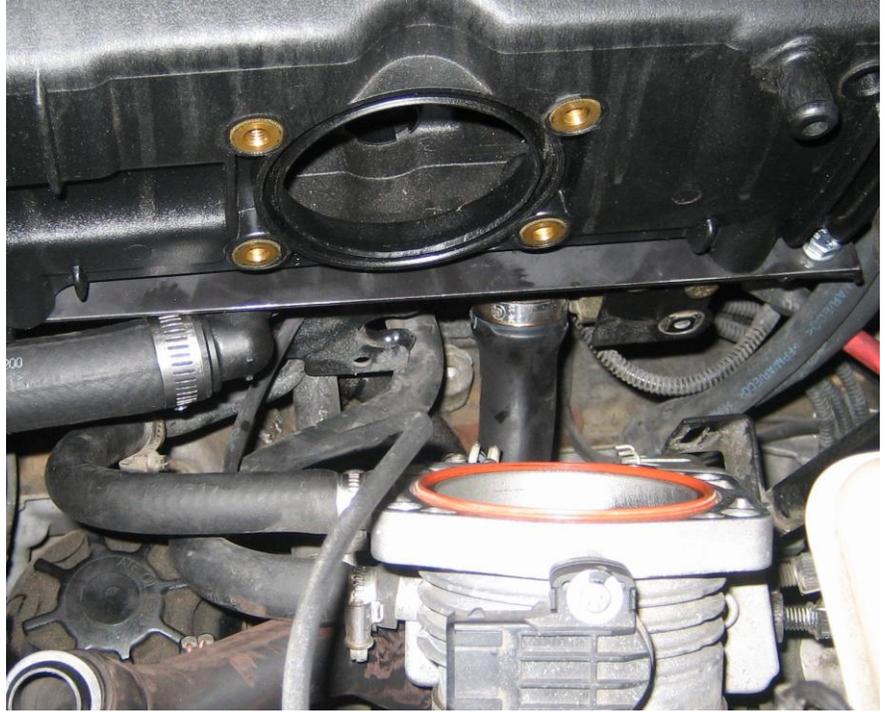
#2 – Throttle Body Seal – The problem is a M50 manifold has a seal gland for a seal to be installed into. The M52 throttle body also has this gland for the seal to be installed into. Photo right.

If you use a standard BMW seal (seen here installed into the M52 TB), you can clearly see that when the throttle body is installed onto the manifold the seal will have nothing to seal against because the sealing area is not flat...it has the seal gland/groove. If you use 2 seals with no sealing plate in between the seals (believe it or not there was a kit manufacturer telling people to do this), they will not seal.

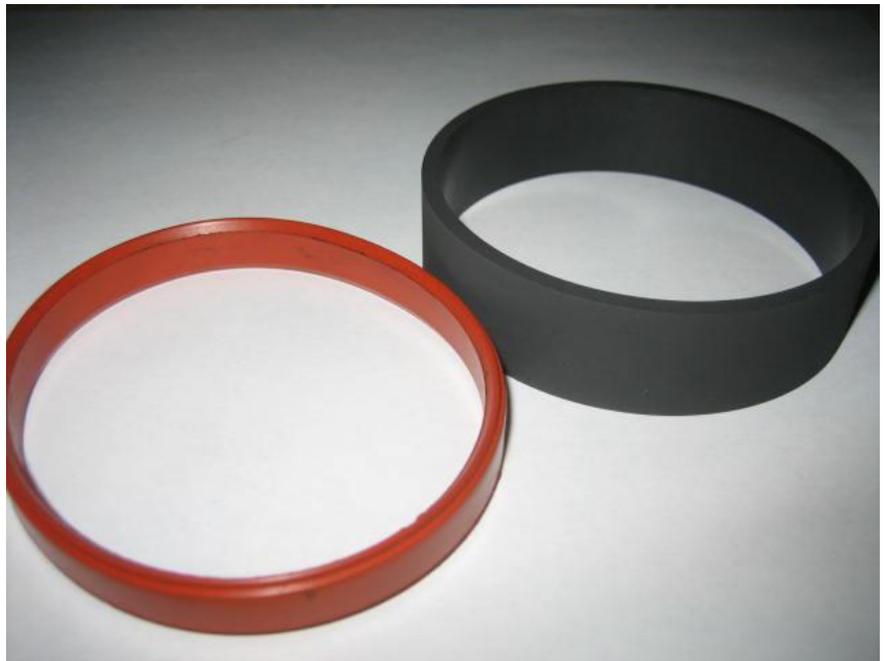
If you buy the m50manifold.com kit a properly designed throttle body seal is included as part of the kit contents. Photo right. It is nearly double the size of the OE seal but not quite. Believe it or not some people even forget to use the m50manifold.com seal even though it comes with their kit.

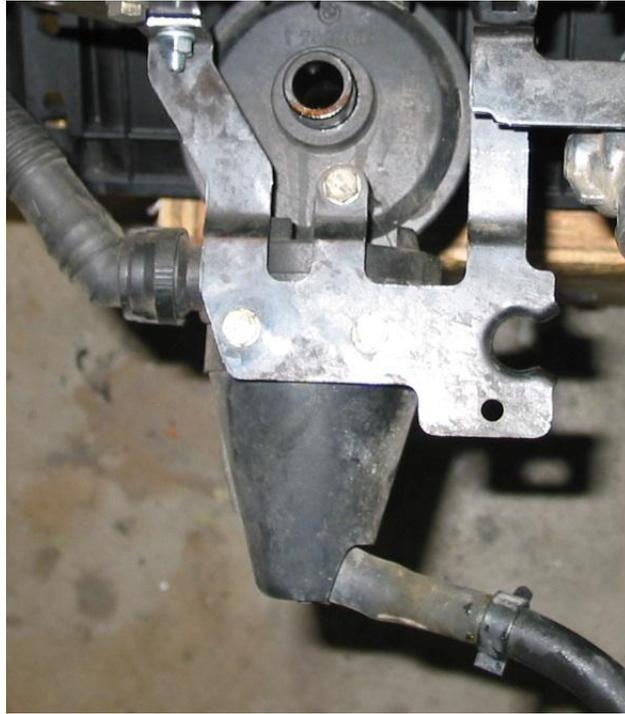
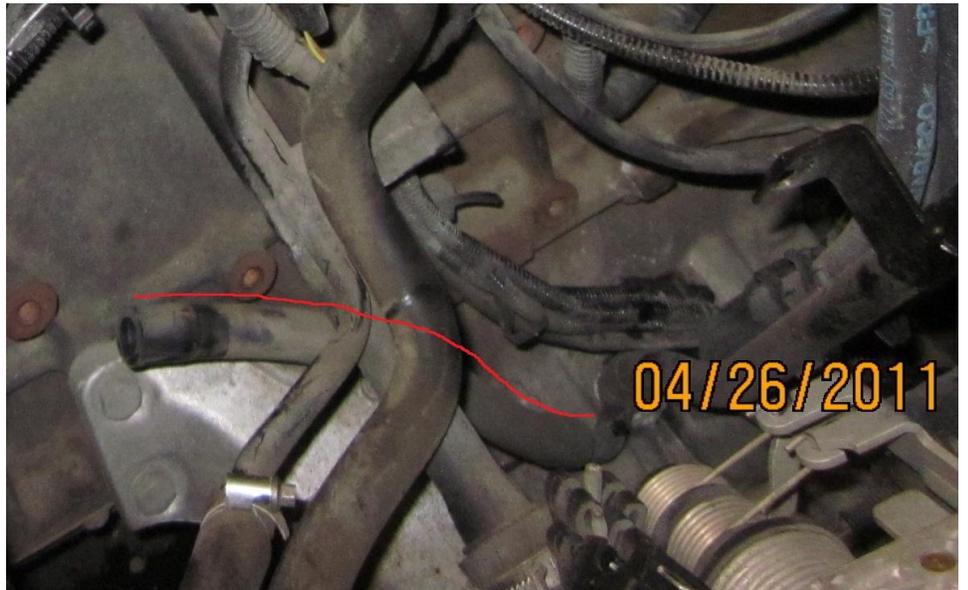
– The most common leak on this component is the drain to the dipstick. The rubber drain hose is often times not in very good shape and can come loose on its own...it is not clamped from the factory.

Otherwise it is also very well hidden beneath many parts so many times it just doesn't get reconnected to the bottom of the crank vent or the dipstick tube. The connection on the side of the crank vent joins the VANOS cover and the crank vent. There are o-ring seals on these connections. The plastic hose can be cracked and the snap ends may not be fully engaged...allowing leakage.

Drain hose to the dipstick pictured right. The ends are often cracked and ugly. Replace if necessary but make sure it is at least connected at both ends. (The date is partially obscuring the dipstick tube making it hard to see.)

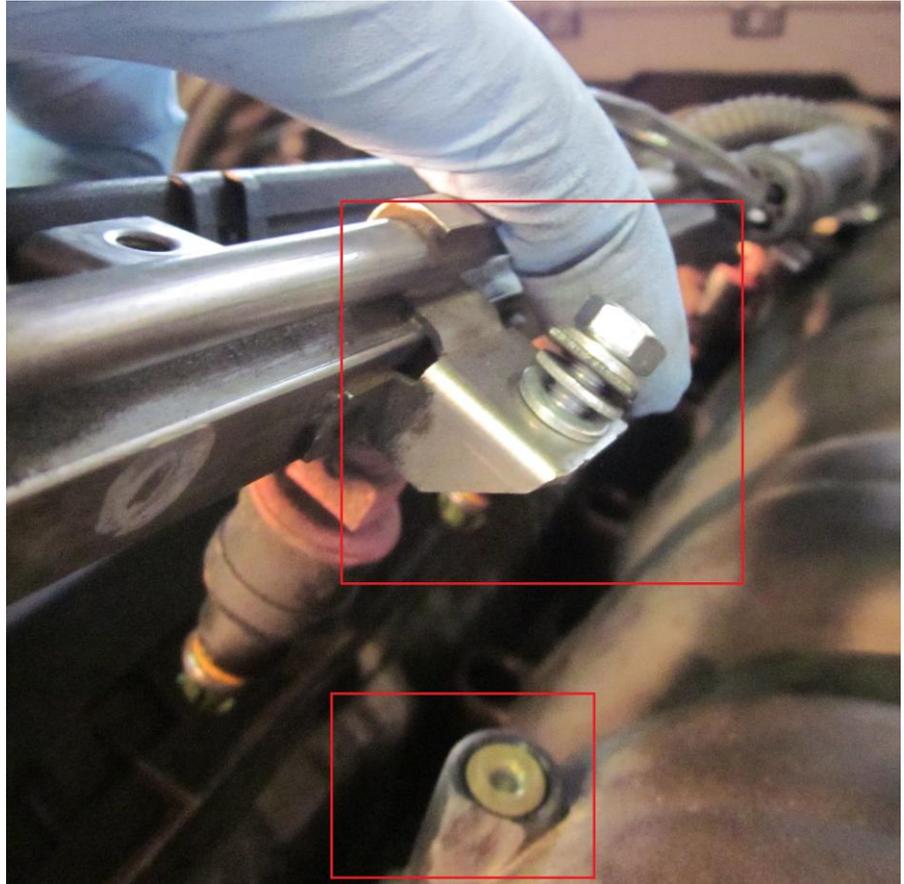
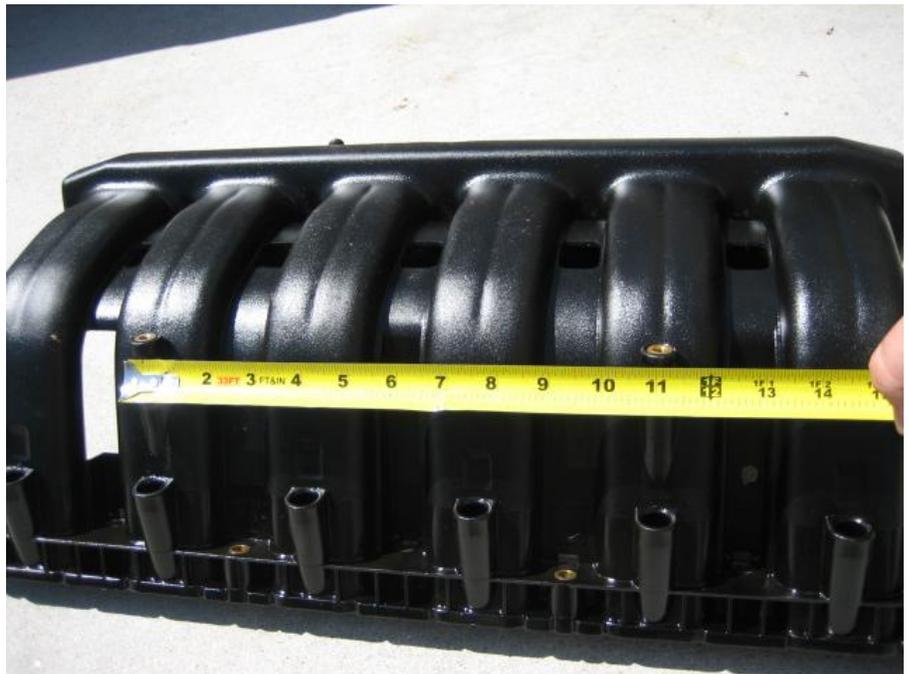
When properly installed, the top of the fuel rail mount is lower than the top of the manifold mount. So if you install brackets without spacers the fuel rail will be pulled up about 3mm...which raises the injector seals 3mm...which allows them to leak.

Use spacers, like washers, to take up the space between the bracket and fuel rail...pushing the fuel rail down forcing the injectors down into their tapered ports sealing them tightly.

Also, you can see that there has been a small amount of plastic trimmed off of the side of the manifold fuel rail mount.

When a M52 fuel rail is mounted to an M50 manifold the fuel rail/manifold mounts make contact in a way that doesn't allow the injectors to sit naturally in their ports. The injectors sit cocked at a slight angle. Trim some plastic off the outside edges just enough so the fuel rail mounts sit outside the mount.

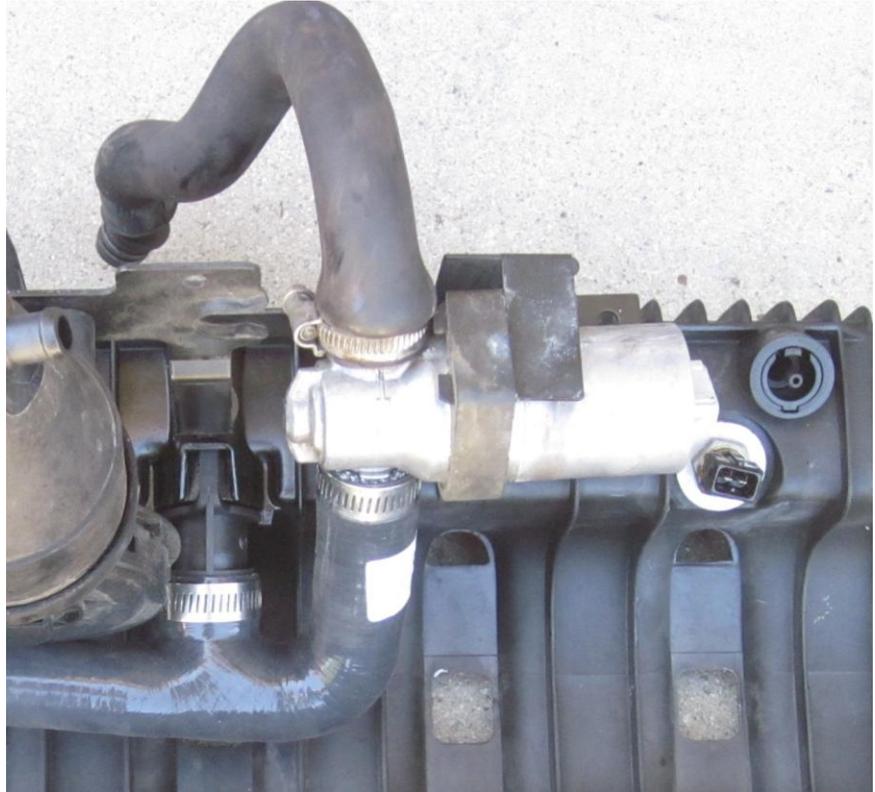
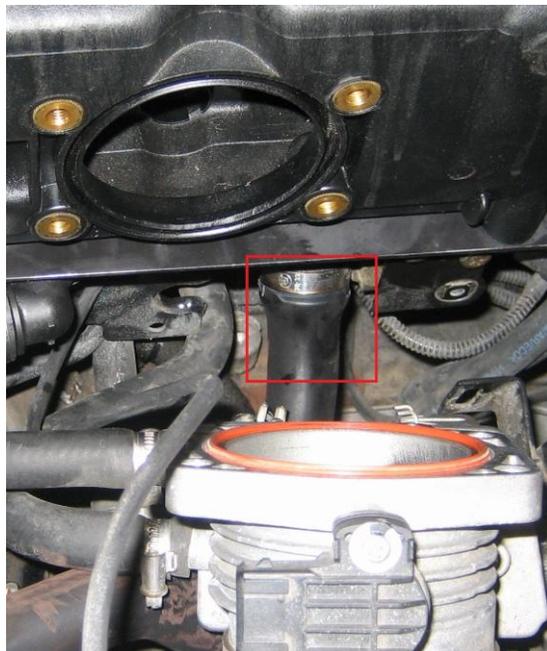
#5 – ICV Leaks – The ICV connects to the intake boot via a molded rubber hose. The hose is often cracked and not in very good shape. I have seen these hoses crack and break right at the hose clamp (shown in the red box below). This break is very difficult to find as it mostly covered by equipment.

This hose break happened to a customer car and it was very illusive. The car would not idle with the AC on. It would idle fine without the AC on and the CEL code faulted the MAF sensor. Substituting MAFs resulted in the same code so I kept looking.

When I install these hoses/clamps I make sure the clamp is accessible from under the throttle body so it can be changed without removing the manifold.

Another ICV problem: Debris in the valve can cause it to stick. If you shake the ICV back and forth the valve can get stuck in full open or closed position. A stuck valve will cause an ICV CEL code. There is more than one CEL code associated with the ICV.
